AN ASSESSMENT OF ABANDONED MINES IN NORTHERN SASKATCHEWAN

(YEAR 3)

An Assessment of Abandoned Mines in Northern Saskatchewan

File R3278 May 2003

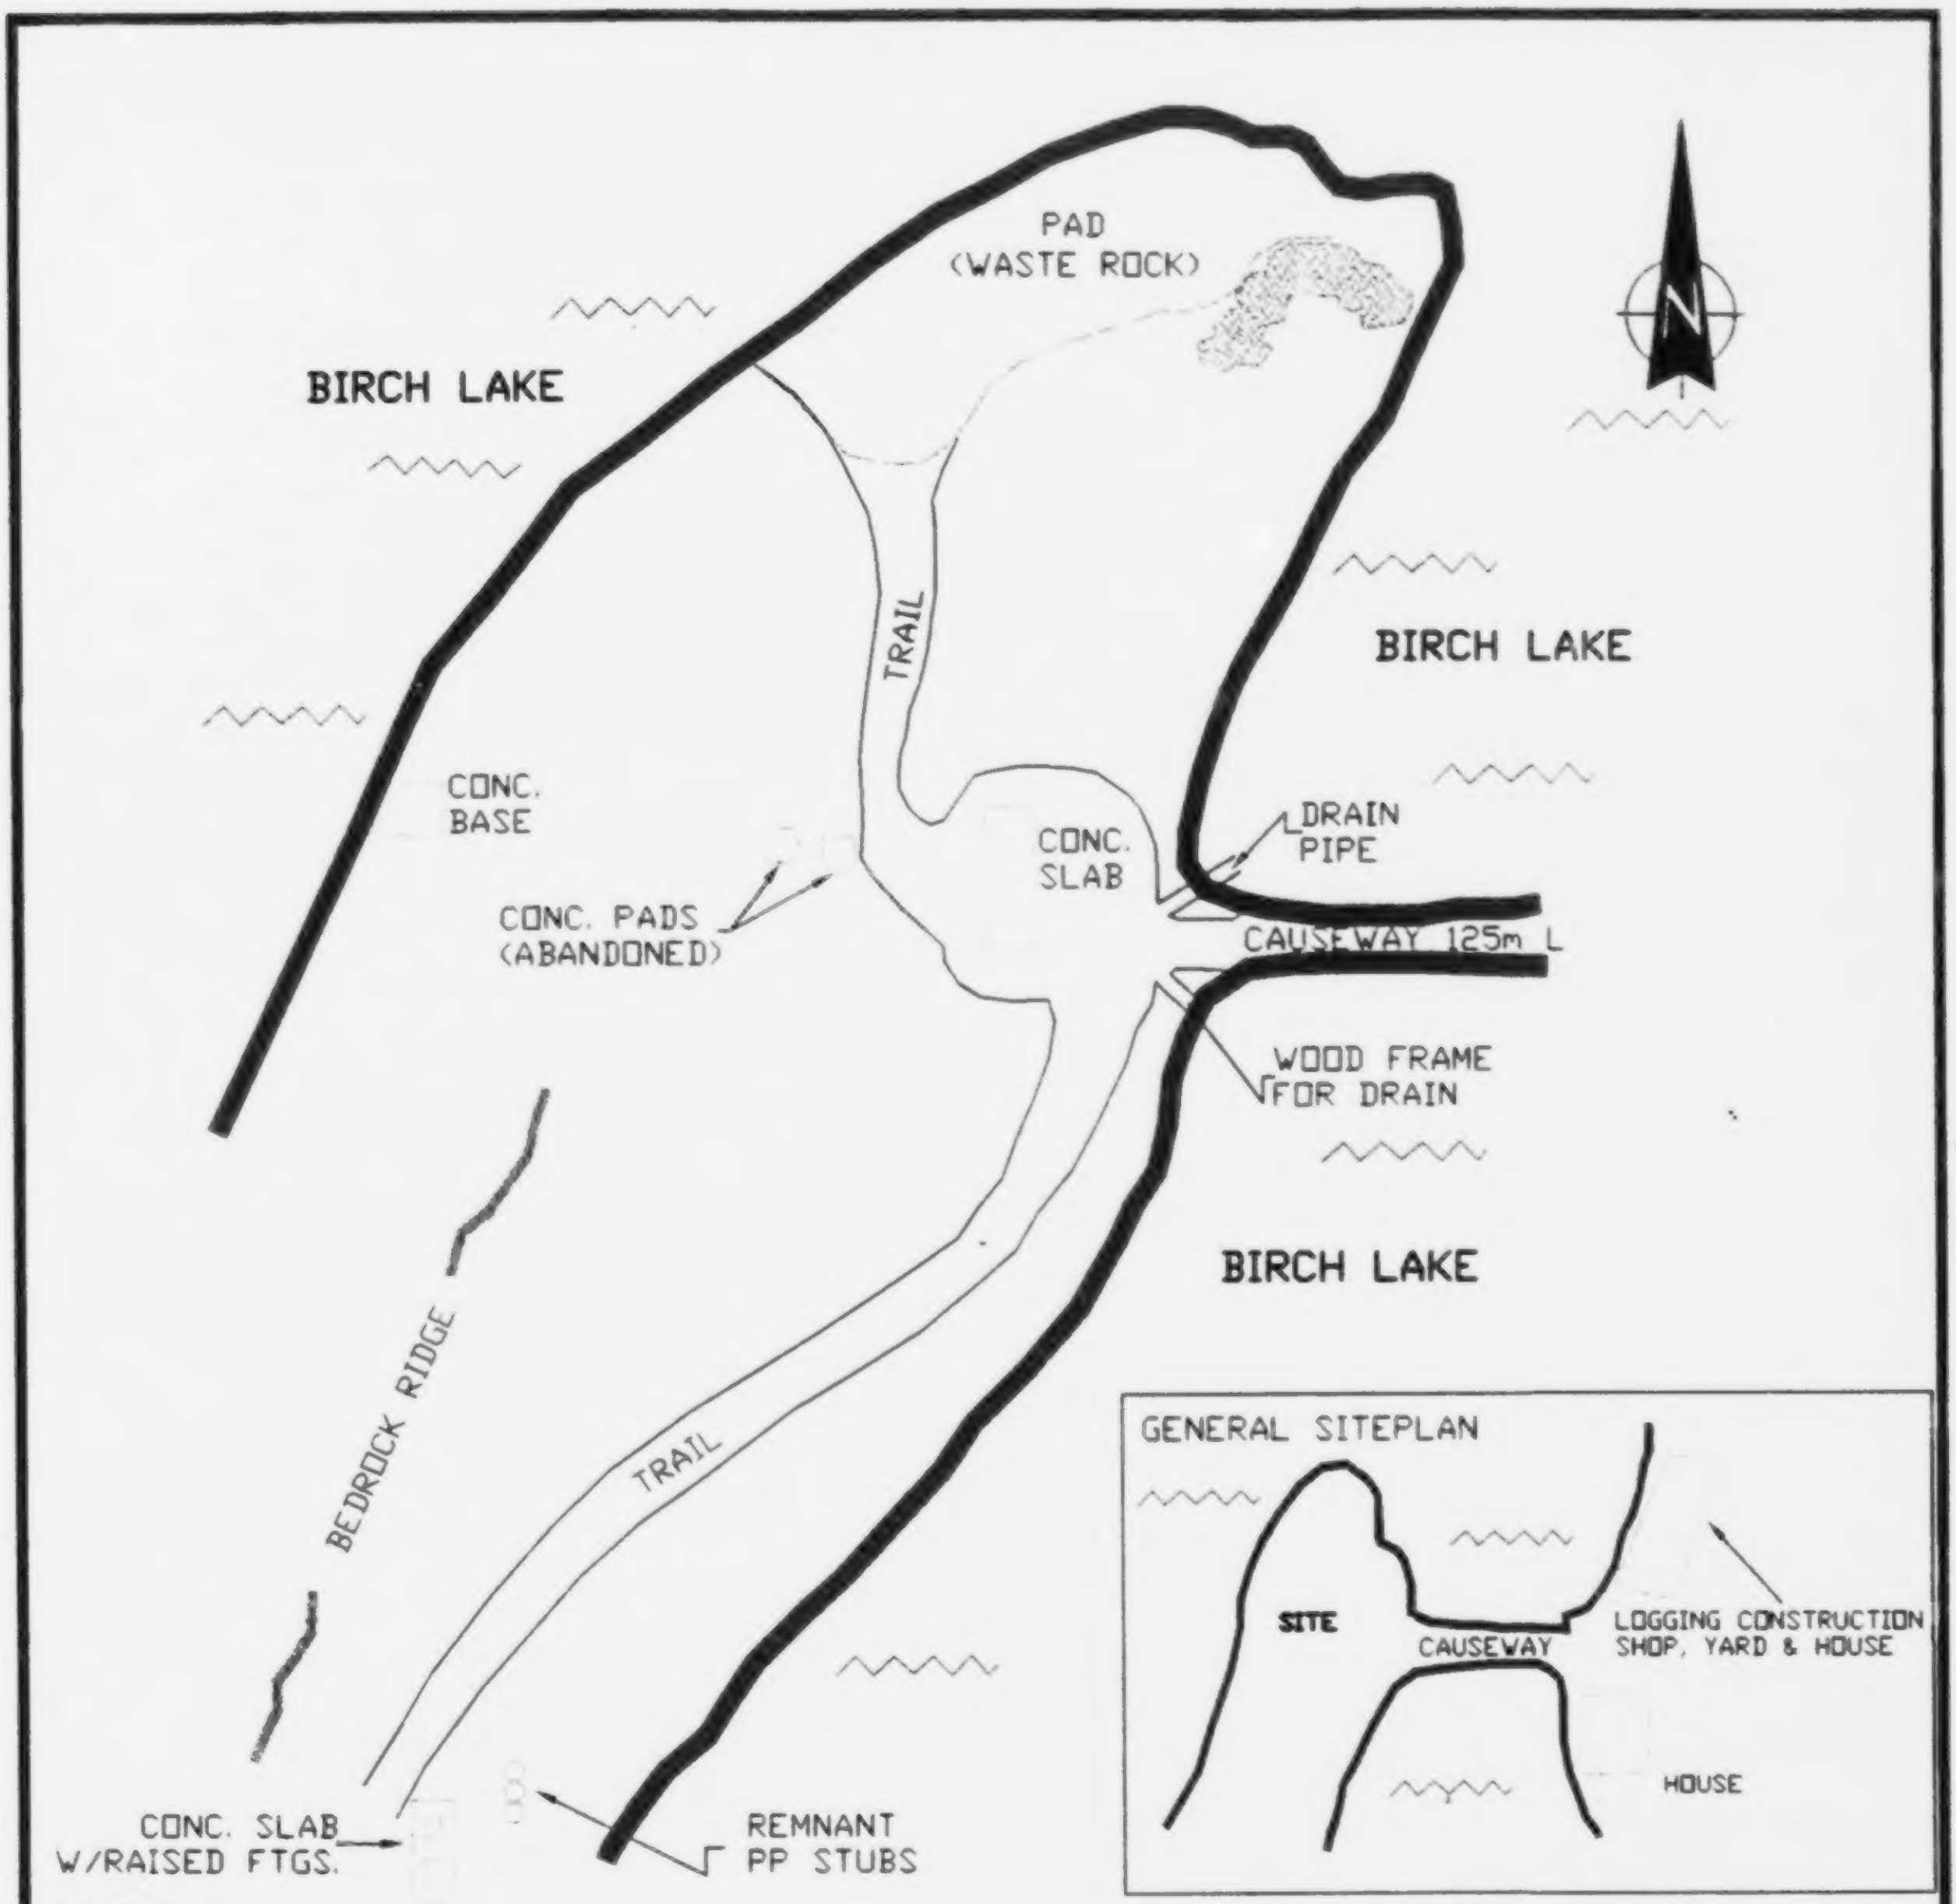
R3278\FIGURE6.18-2.DWG

The semi-cleared area of the former workings is about 80 m wide and 90 m long and covering about 0.7 hectares. No open workings were found. No public safety hazards were identified.

A horizontal 200 mm diameter steel pipe protrudes from the waste rock on the east side of the island beside the causeway. The pipe rests on remnant wood framework. The pipe was dry and there was no visible staining on the surrounding ground. On the other side of the causeway there was a similar remnant wood framework but no steel pipe or staining. The pipe is interpreted to be the remnants of a drainage pumping system used to keep the mine from flooding.

The remnant concrete foundations are in good condition with no openings, and do not present a public safety or environmental hazard.

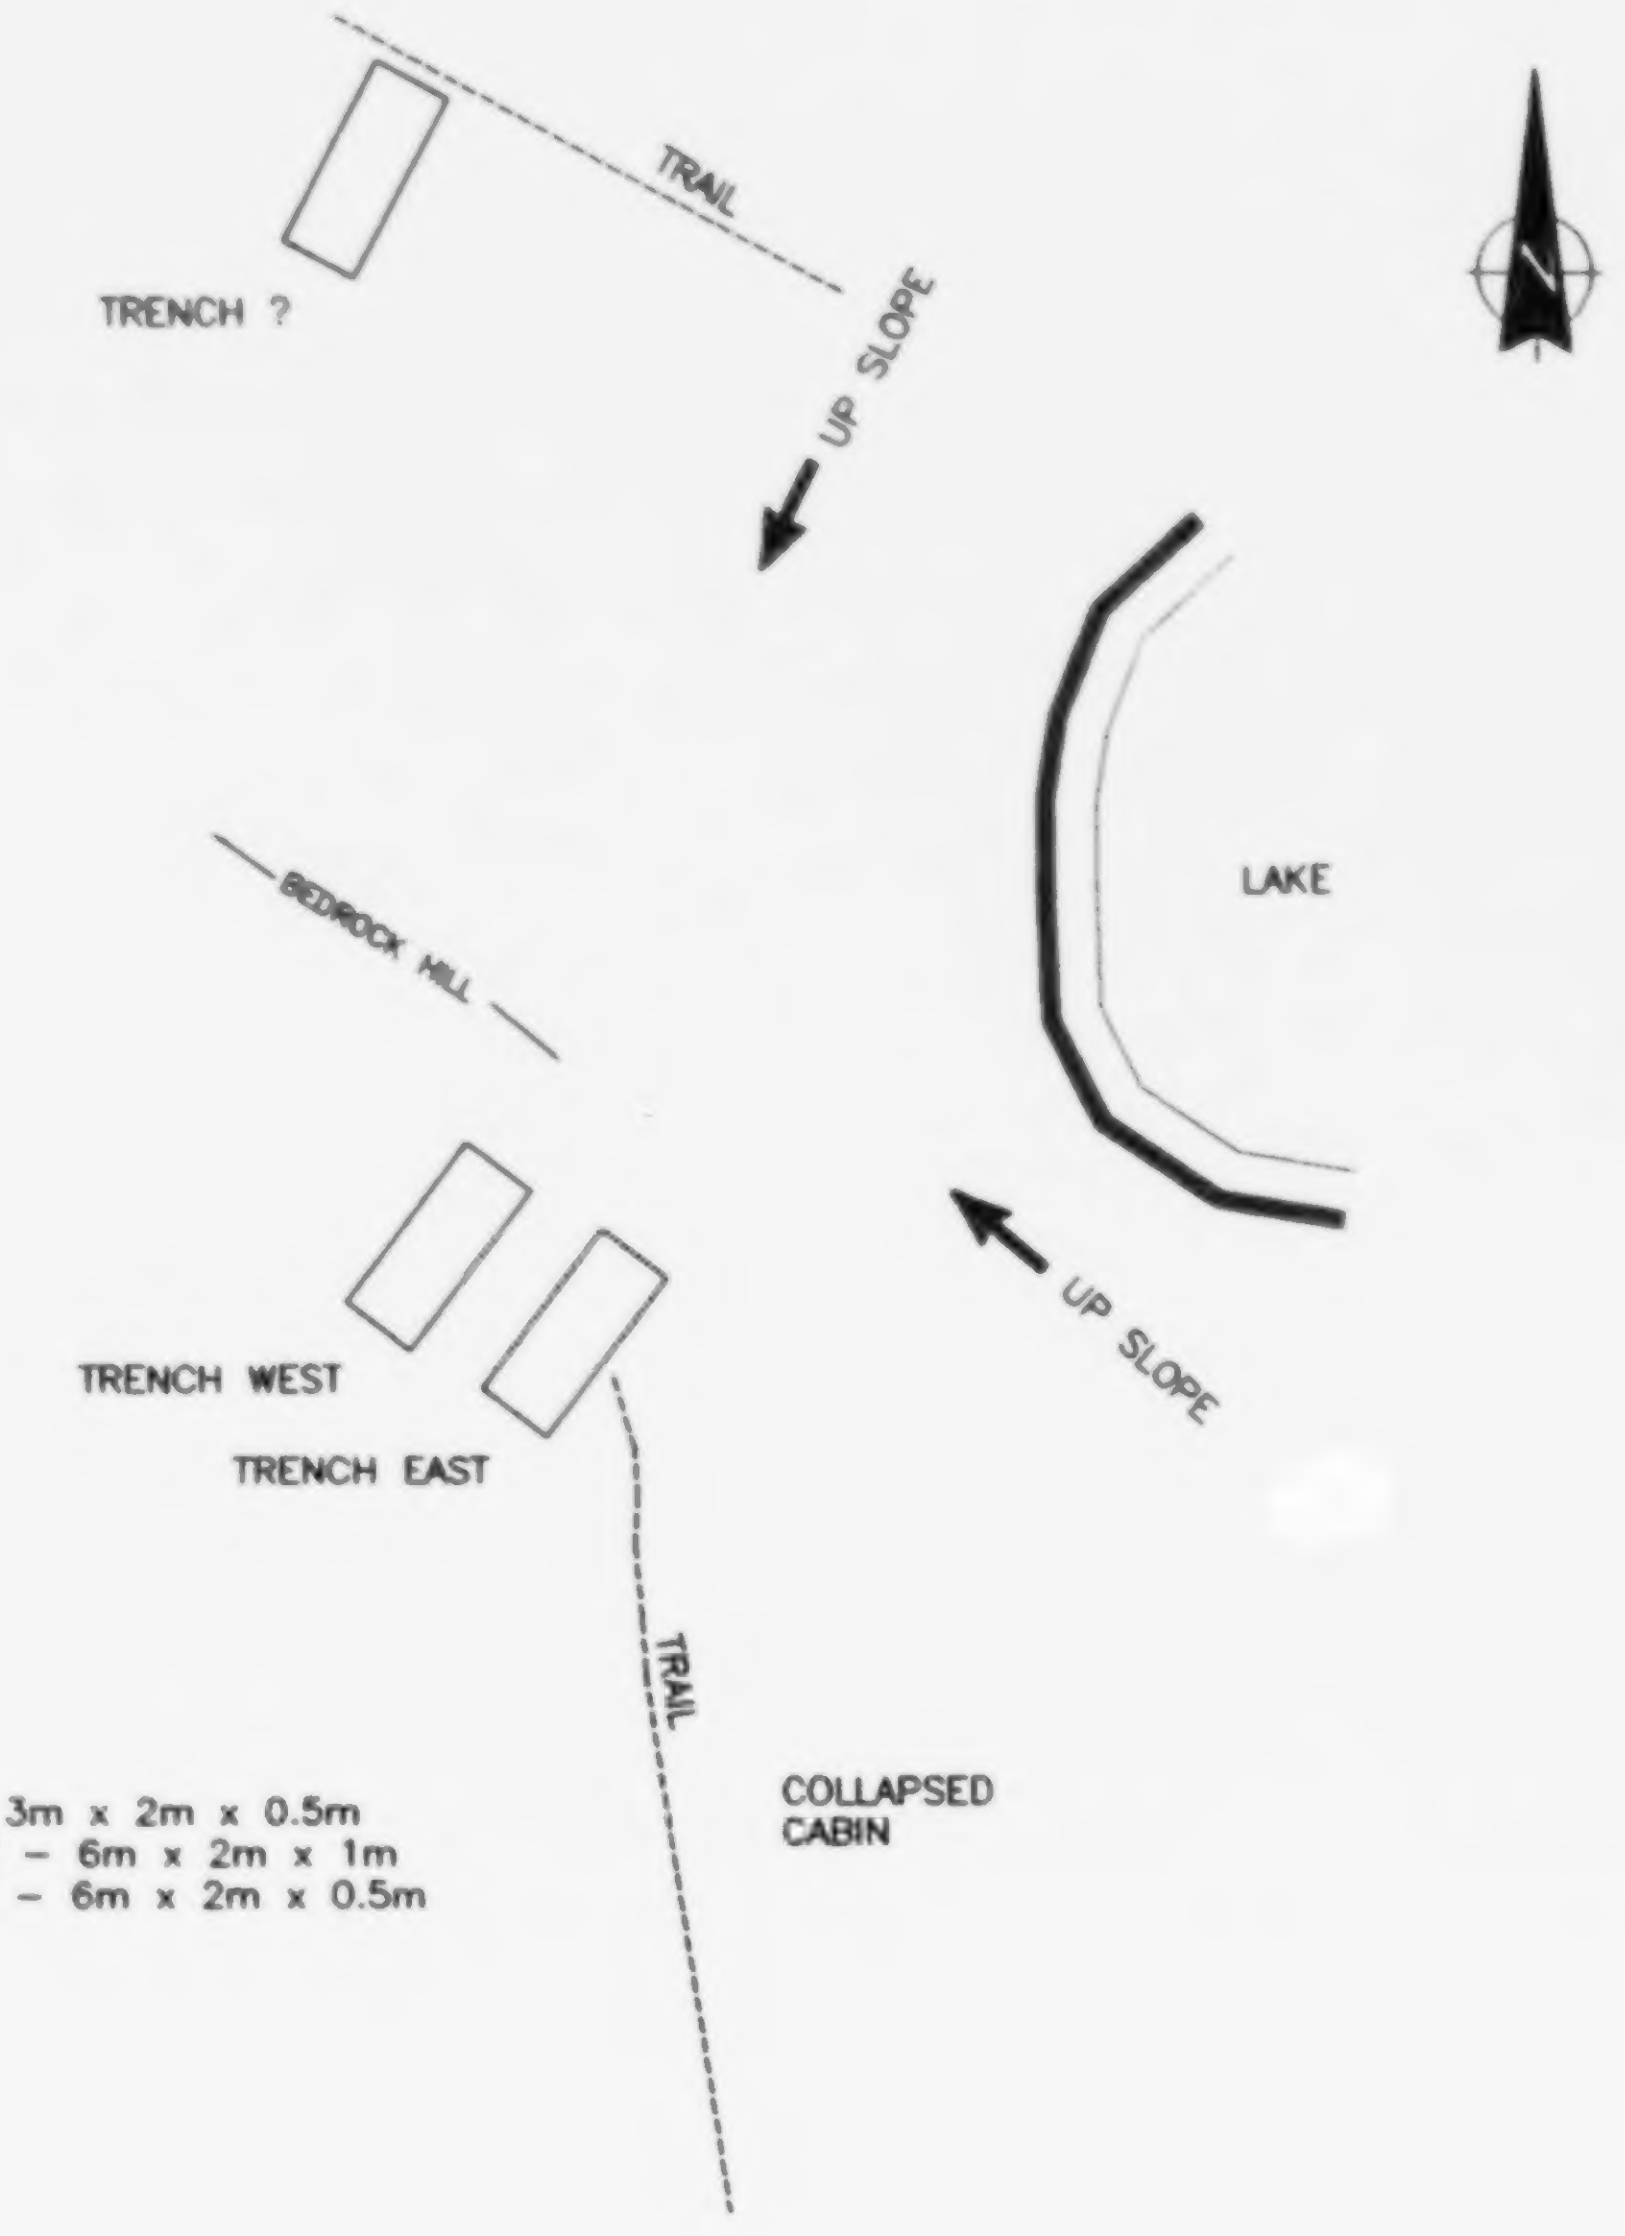
CLIFTON ASSOCIATES LTD. **PROJECT NO: R3278** **FIGURE NO: 6.24–4**

TRAIL
TRENCH ?
UP SLOPE
LAKE
BEDROCK HILL
UP SLOPE
TRENCH WEST
TRENCH EAST
TRAIL
COLLAPSED
CABIN

Mine workings at the No. 3 Deposit consist of two shallow trenches in an area of stripped bedrock, exposing quartz veining. The trenches were difficult to discern but appear to be 6 m long, 2.4 m wide and up to 1m deep. Trench-West extends into a flooded depression ingrown with bulrushes. Extensive quartz veining was exposed in Trench-West. The slopes walls of the trenches are shallow and stable, and do not pose a public safety hazard. North of No. 3 Deposit, beside a portage / snowmobile trail, was what appears to be a shallow, newer-looking, rock trench.

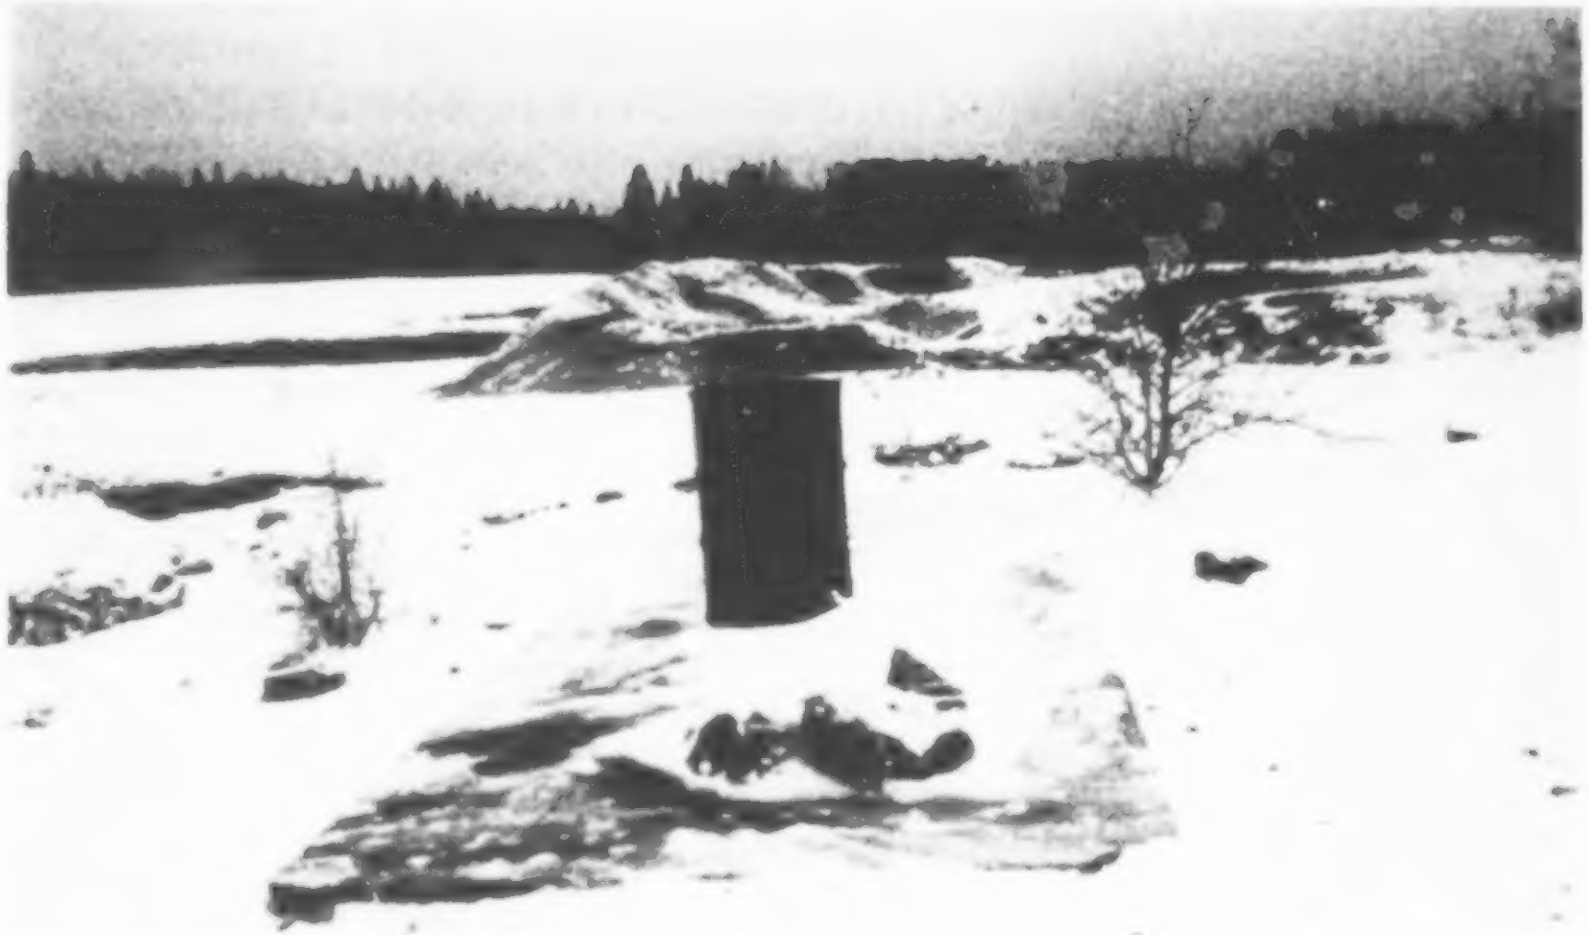
Photograph 6.29-5. Coronation Mine-Concrete Slab 'C'-October 28, 2002.

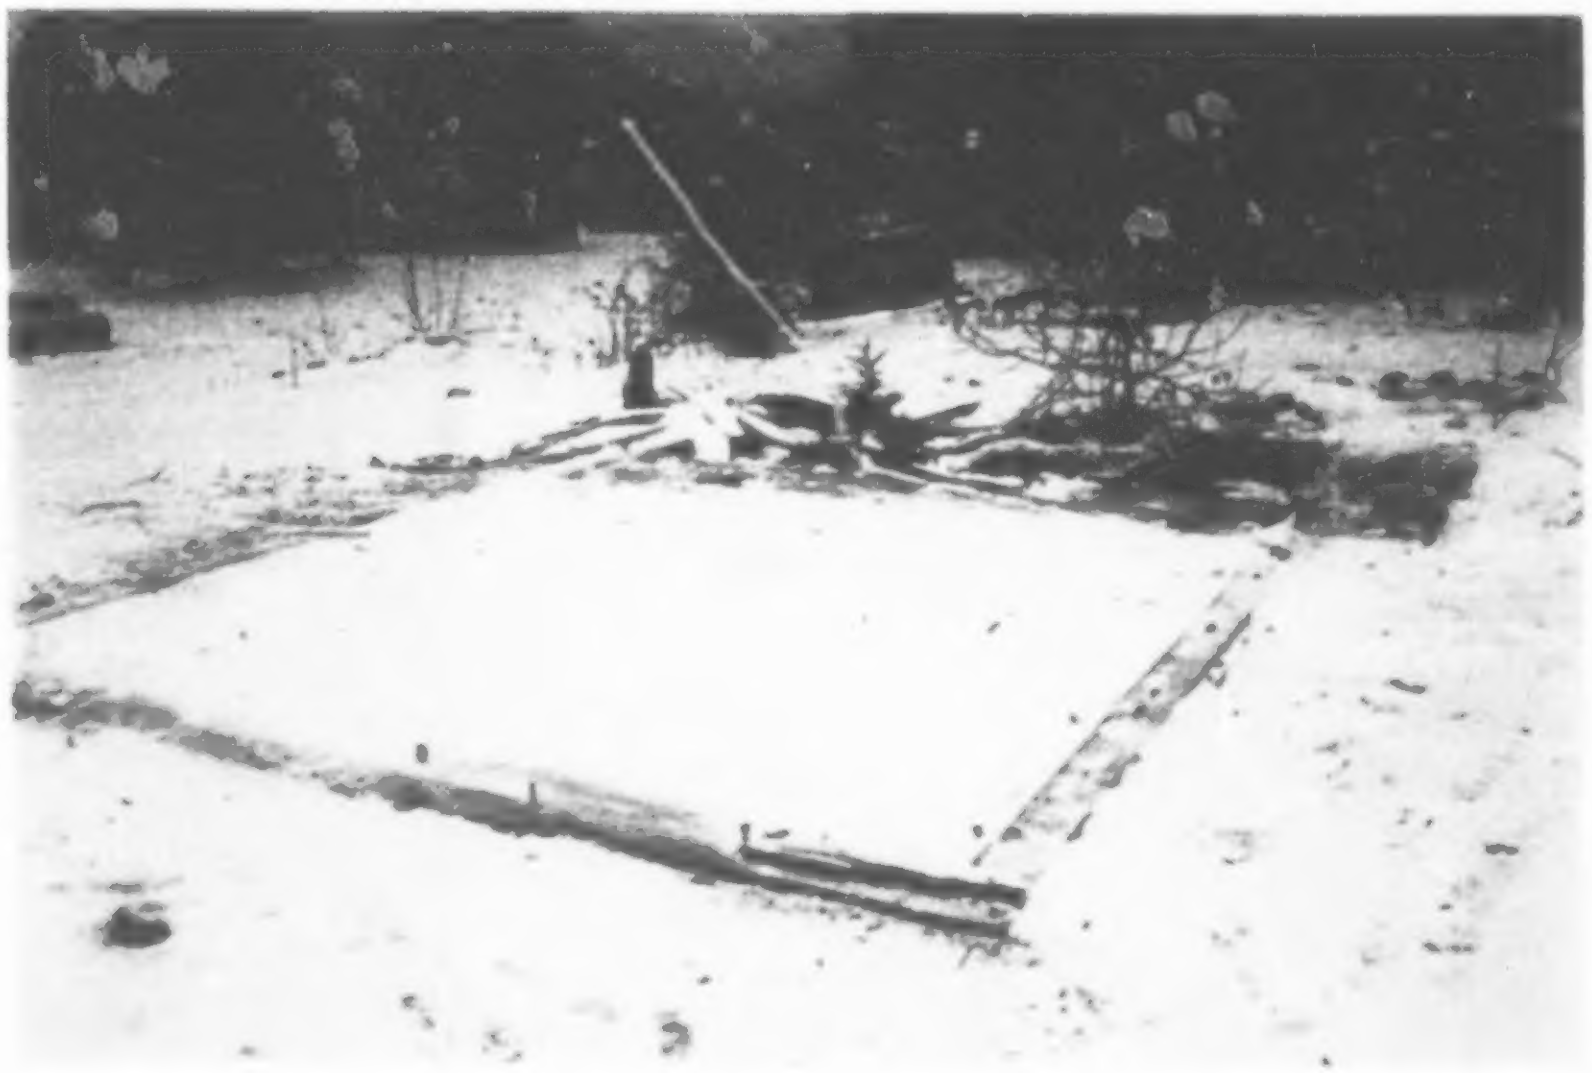
Photograph 6.29-7. Coronation Mine-Concrete Foundation 'E'-October 28, 2002.

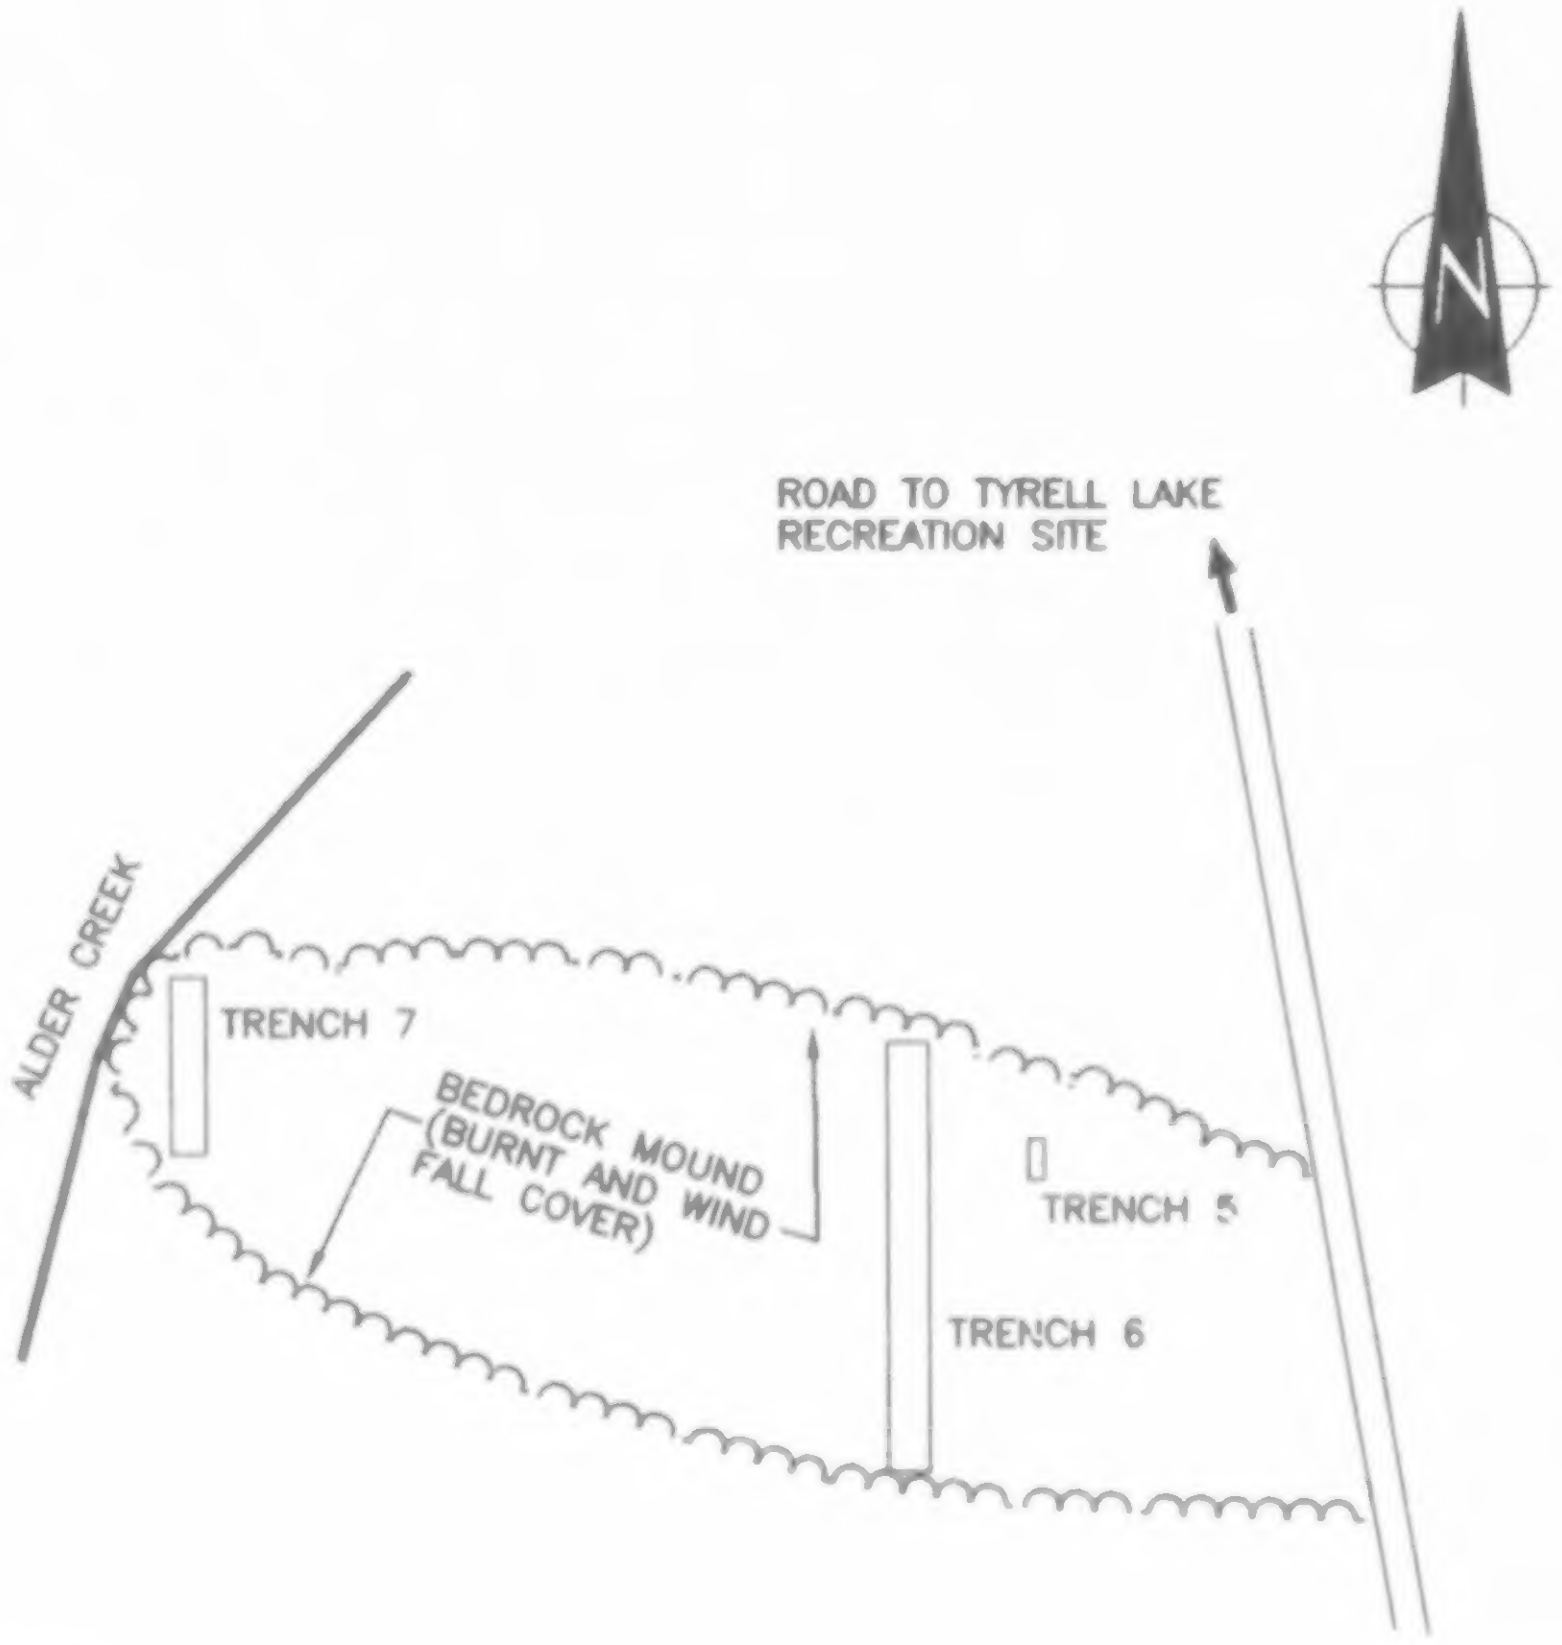
N
ROAD TO TYRELL LAKE RECREATION SITE
ALDER CREEK
TRENCH 7
BEDROCK MOUND (BURNT AND WIND FALL COVER)
TRENCH 5
TRENCH 6

DIMENSIONS:
TRENCH 7 – 12m x 2m x 2m
TRENCH 6 – 25m x 2m
TRENCH 5 – 2m x 1m x 1m

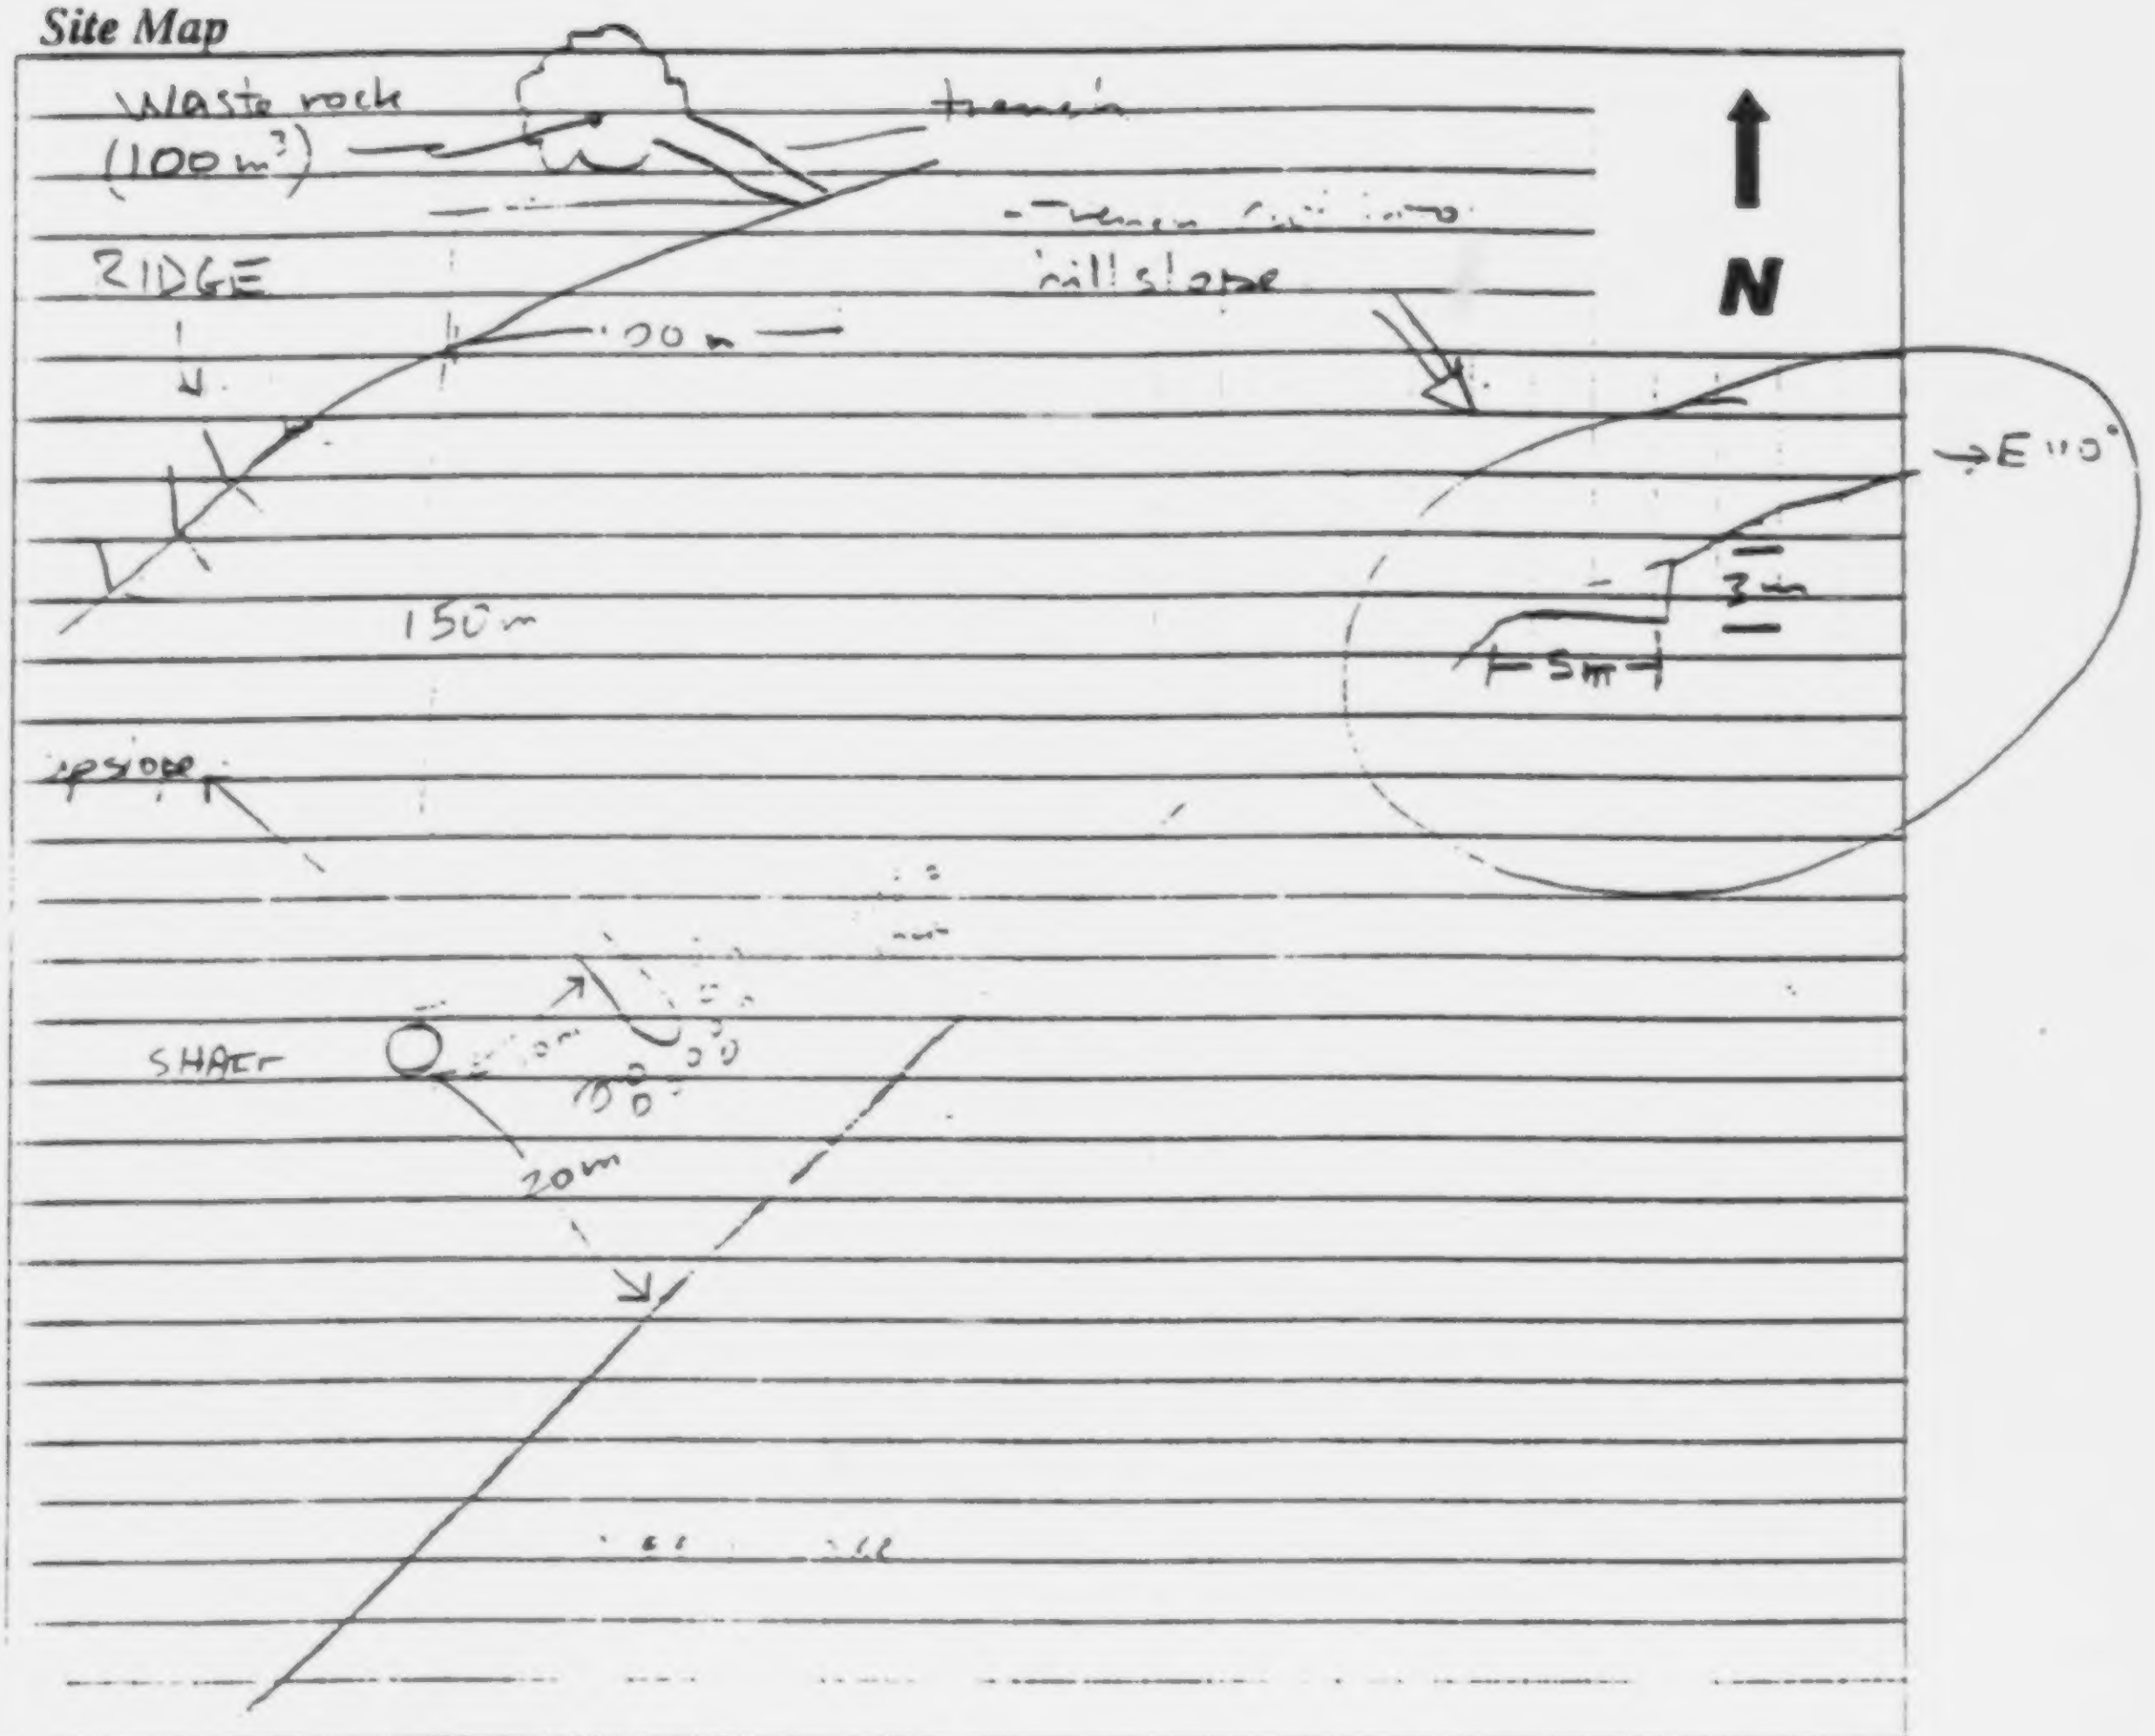
Site Map

Scrap Material			
Type	Assorted		
Estimate Amount	50 m^3		
Risk to Environment	1 (low) 1	2	3 (high)
Risk to Wildlife	1 (low) 1	2	3 (high)
Risk to Public Safety	1 (low) 1	2	3 (high)
Residual Chemical on Site	No		
List Type	Drill Stem	lumber	Scrap metal
Estimate Volume of Each	20 x 3m' lengths	20 m^3	20 m^3
Type of Storage	None	None	None
Type of Containment (if any)	None	None	None
Risk to Environment	1 (low) ①	2 ①	3 (high) ①
Risk to Wildlife	1 (low) ①	2 ①	3 (high) ①
Risk to Public Safety	1 (low) ①	2 ①	3 (high) ①
Mine Dewatering	No evidence of Dewatering lines.		
Locate Discharge if Possible	None.		
Additional Comments	Assorted debris around shaft area includes drill stem. lumber, pipes, cribbing, cable. tin.		
Other Information	Debris is aesthetic concern only. No evidence of environmental concerns.
